AVERAGE SETBACK COMPUTATIONS: 123A SPA VIEW AVENUE

SETBACK EXHIBIT
#123A SPA VIEW AVENUE
 123A SPA VIEW AVENUE, ANNAPOLIS, MARYLAND 21401
 TAX ACCT. NO. 06-000-03200155 ~ SDP2017-005
 TAX MAP 051F GRID 010 PARCEL 0349 DISTRICT 6TH
 ANNE ARUNDEL COUNTY, CITY OF ANNAPOLIS, MARYLAND
 DATE: AUG. 30, 2017 SCALE: 1"=60'

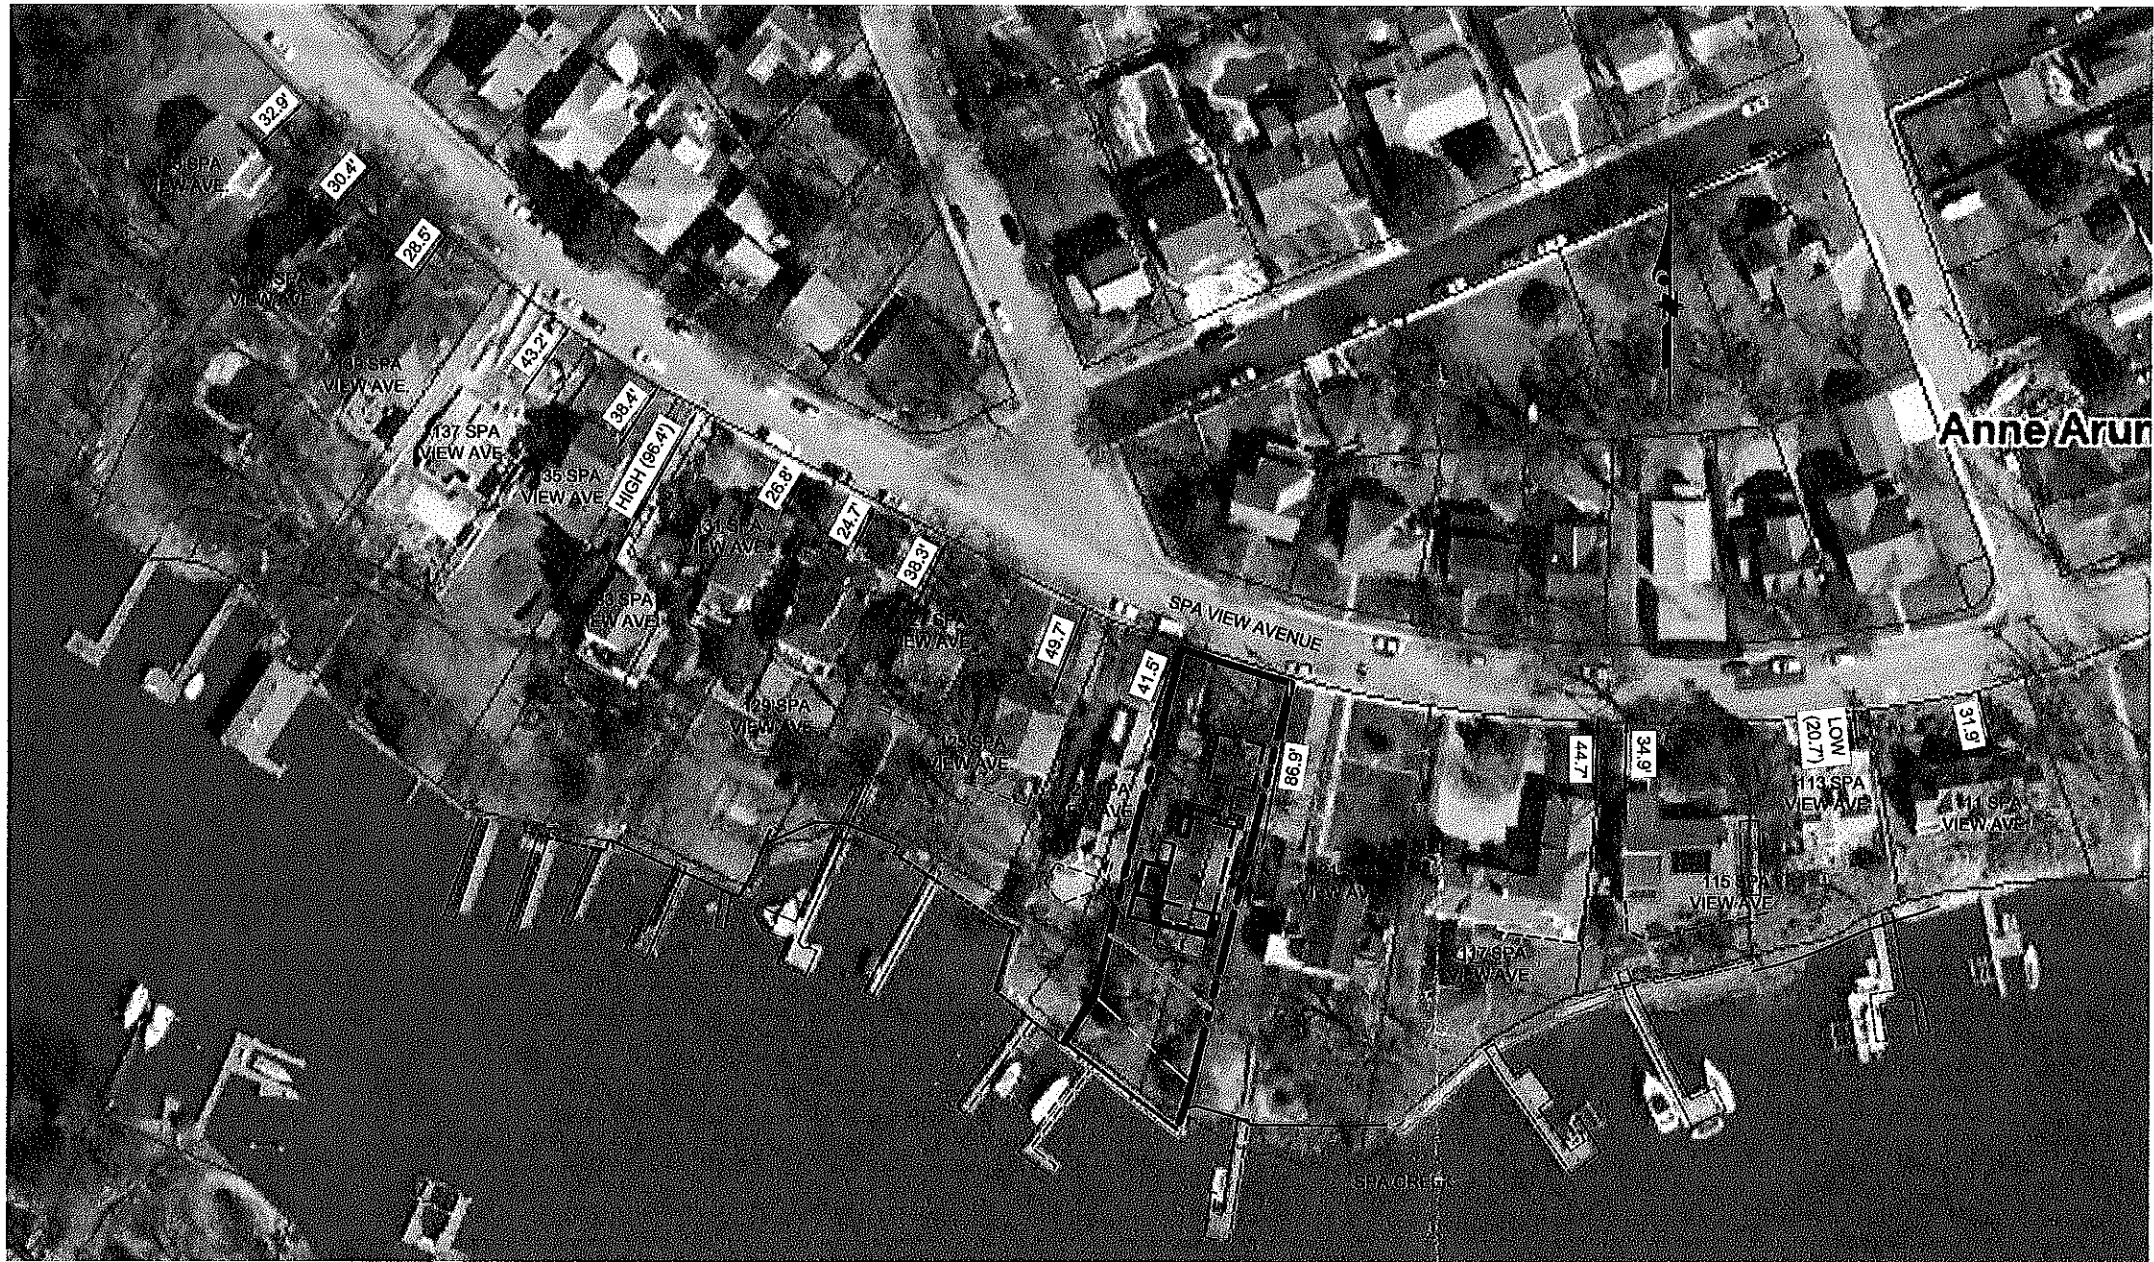
AVERAGE HEIGHT COMPUTATIONS:	30.2
AVERAGE PEAK SETBACK:	63.3
ESTABLISHED FRONT YARD SETBACK:	39.5
AVERAGE WATERWAY YARD SETBACK:	60.2

*The smallest and largest yards have been excluded from the computations
 **All dimensions used were taken from the best available information
 ***Established front yard setback with Administrative Adjustment: 31.6'
